FULL RESERVE STUDY

Harbor Oaks Townhouses Association, Inc.

Charleston, South Carolina
September 26, 2017

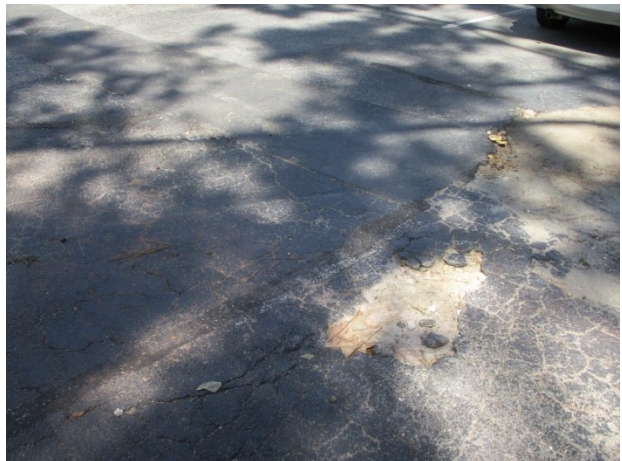
Condition: Fair overall with cracks and deterioration evident

Pavement deterioration

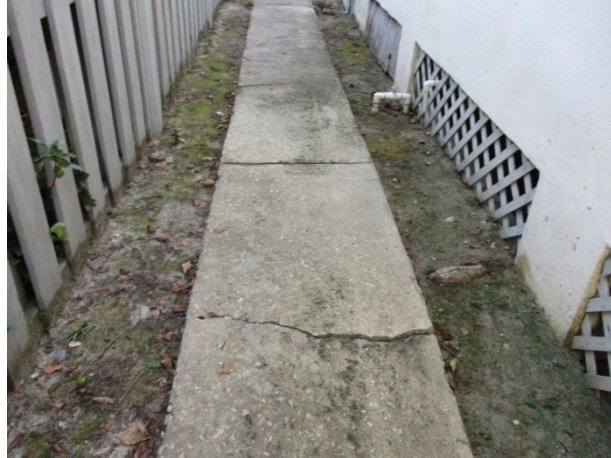
Condition: Good to fair overall with isolated cracks evident

Sidewalk crack at the clubhouse

Expenditure Detail Notes: Expenditure timing and costs are depicted in the **Reserve Expenditures** table in Section 3. We estimate that up to 1,980 square feet of concrete sidewalks, or forty-five percent (45%) of the total, will require replacement during the next 30 years.

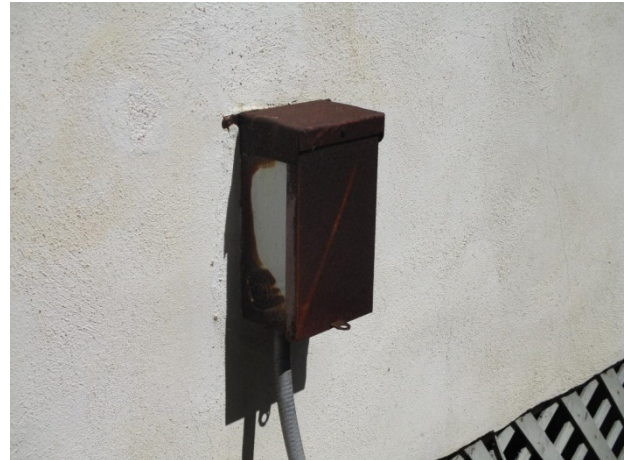
Rusted control box at condensing unit-maintain through operating budget

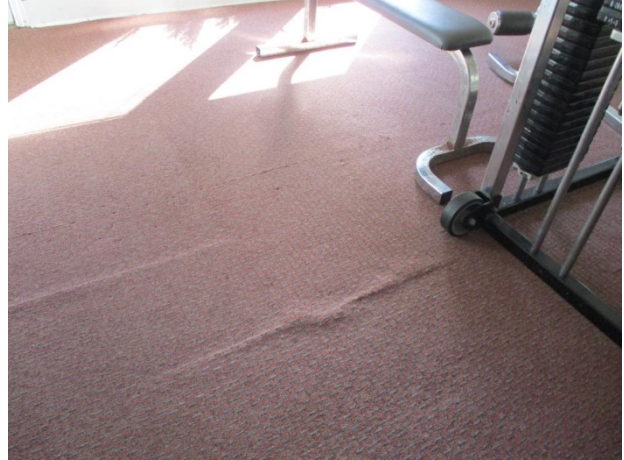
Condition: Fair overall

Exercise room carpet

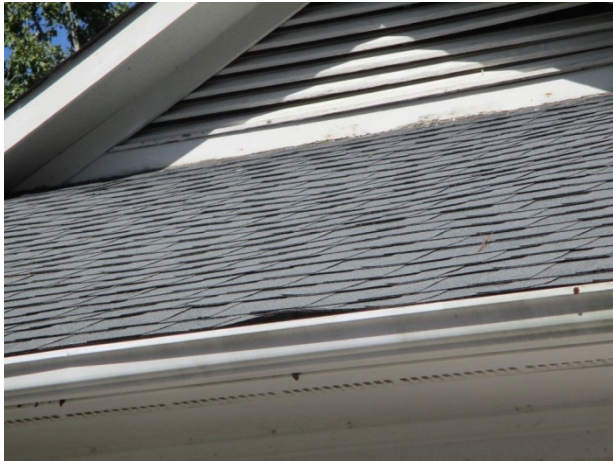
Lifted shingle

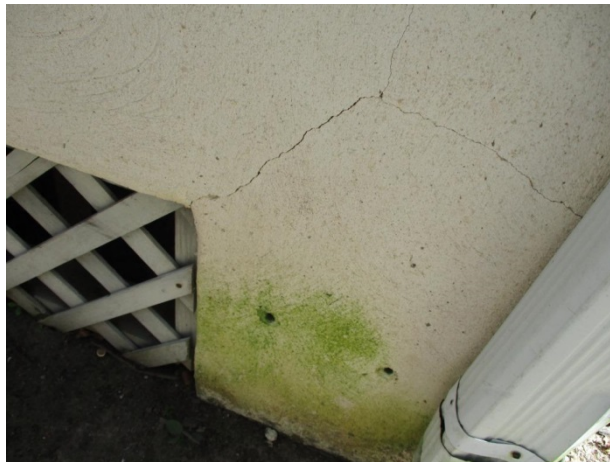
Condition: Good to fair overall with isolated cracks evident

Stucco cracks and discoloration

Useful Life: We recommend inspections, repairs and paint finish applications every six- to eight-years.

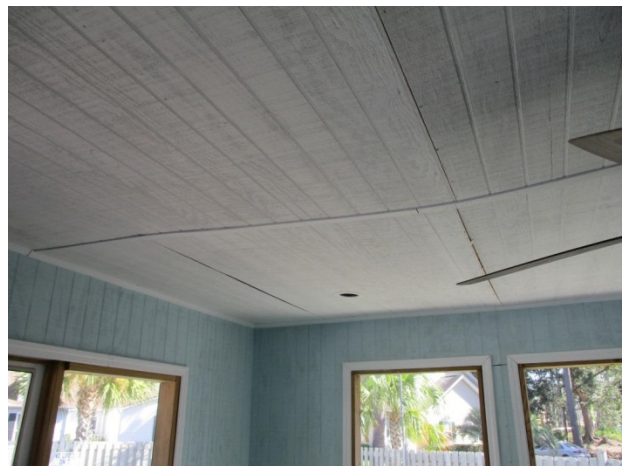
Condition: Fair overall

Deflected wood ceiling of sun room

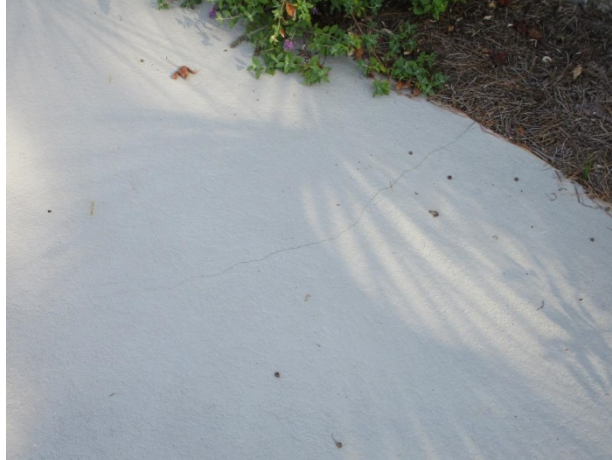
Minor crack in deck

Useful Life: The useful life of a concrete pool deck is up to 60 years or more with timely repairs. We recommend the Association conduct inspections, partial replacements and repairs to the deck every 8- to 12-years in conjunction with coating replacements.
